Case History

The importance of monitoring Shaft Centerline data

by Mark A. Jordan,
Vibration Specialist
Bently Nevada Corporation

This article discusses the basic theory behind Shaft Centerline monitoring and the problems experienced in a recent field study where startup assistance was provided on main process machinery. A case history is also included which focuses on severe misalignment problems experienced during initial machinery startup. The problem was further compounded by a loose bearing retaining setscrew. This case history demonstrates that Shaft Centerline information is an important part of the diagnostic process as it provides additional information on complex machinery malfunctions.

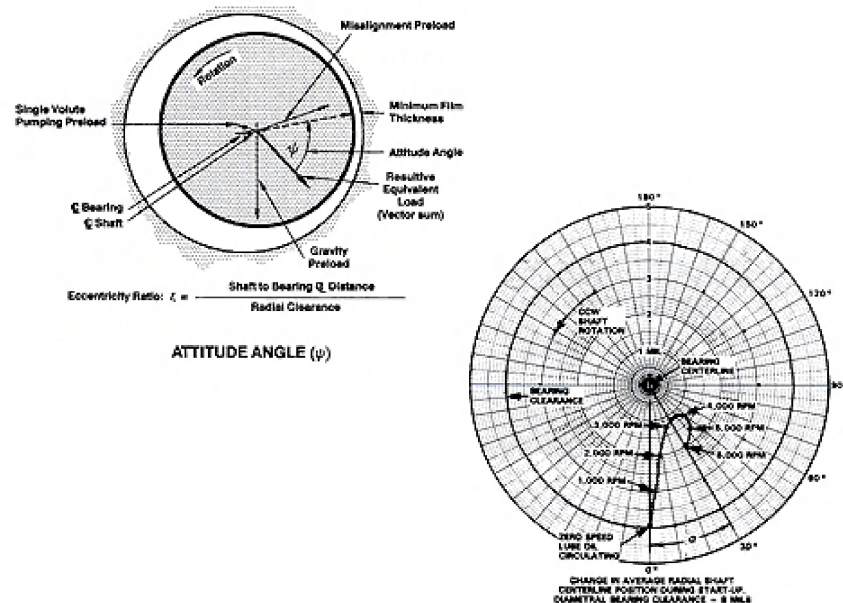
The attitude angle can be obtained from Shaft Centerline data quite easily as long as care has been taken in determining the correct bearing clearance and zero speed gap voltage reference. In general, evaluation of the shaft attitude angle provides an indication of the stability margin for a particular machine. As long as machine alignment is correct, and the parameters for Shaft Centerline measurements have been observed, an attitude angle approaching 90° is indicative of instability within the system. Refer to Figure 1 (normal) and Figure 2 (abnormal).

Shaft attitude angle definition (left). An example of how the shaft radial average centerline position changes during startup (right).
